Photographs

These Photos are representative of issues presented with the report. All pictures are provided in electronic format with audio descriptions on disks. All descriptions are repeated in writing in the accompanying report.

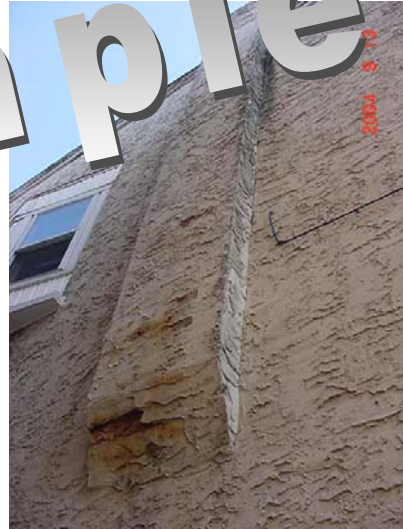
Photo 4 – Chimney parging is delaminating due to trapped and freezing rain.

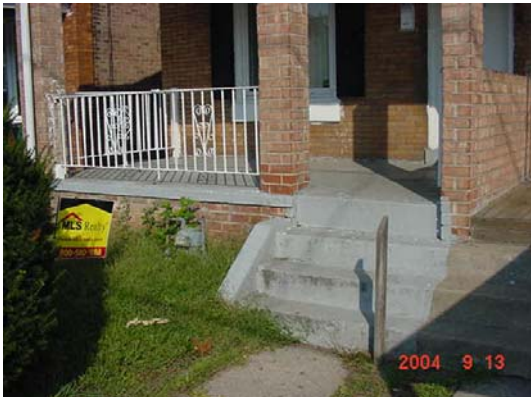
Photo 2 – Railing is loose and improper.

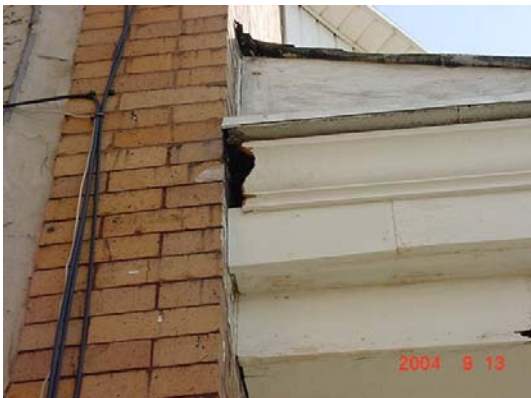
Photo 3 – Fascia trim is short allowing birds to nest.

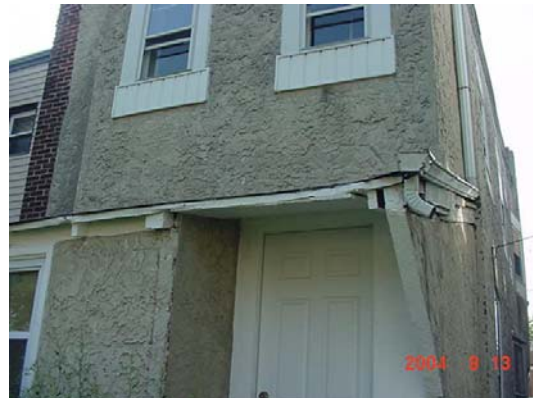
Photo 5 – Rear left corner is damaged allowing water to intrude exterior.

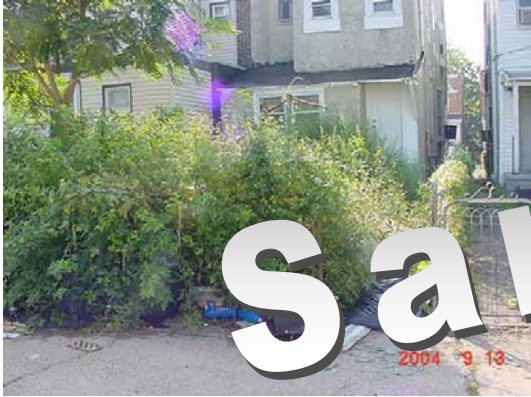
Photo 6 – Over grown vegetation and rubbish indicates prolonged neglect.

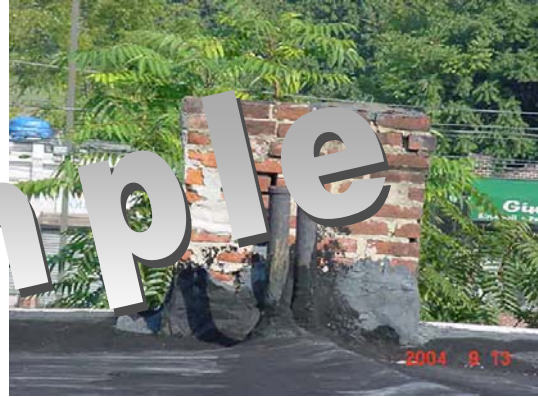
Photo 9 – Loose bricks need pointing, close vent stacks are difficult to keep sealed. Recommend replacing chimney flue and add a rain cap.

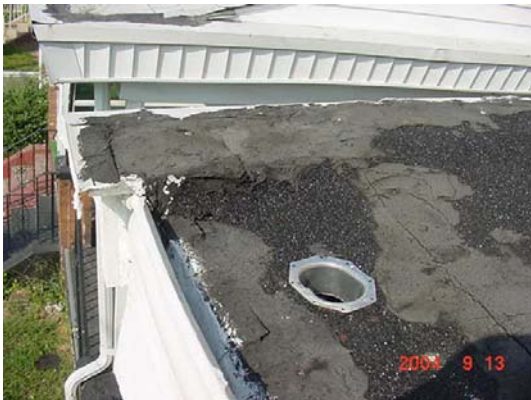
Photo 7 – Hot mopped roof is cracking and the roof drain is easily blocked by leaves and balls thrown onto the roof.

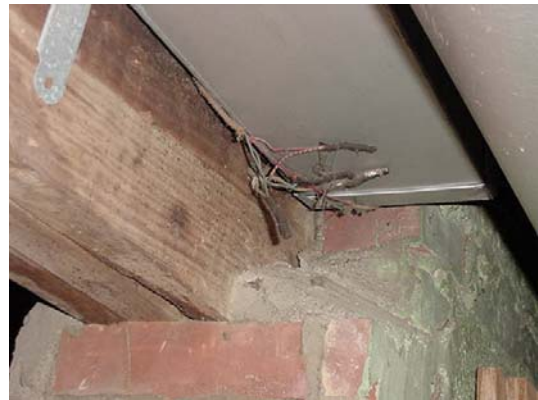
Photo 10 – Open wiring is dangerous and a code violation. All splices must be in a junction box.

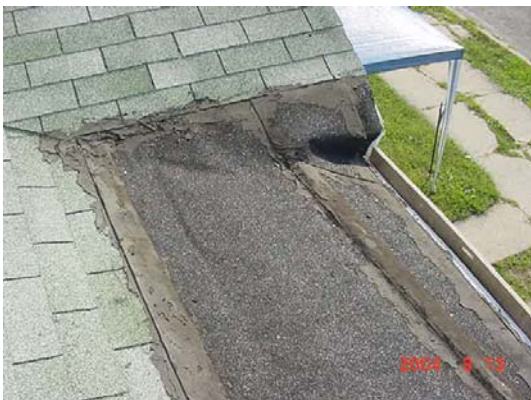
Photo 8 – Flashing and seams are high maintenance.

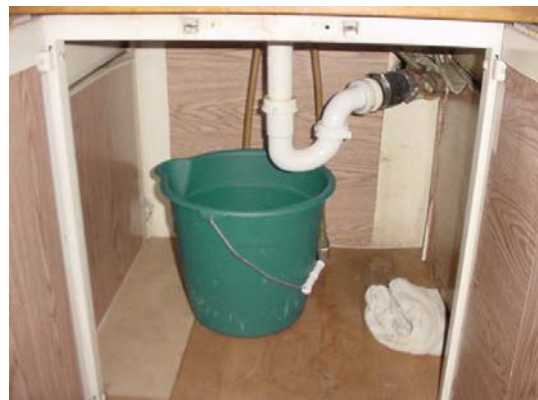
Photo 11 – Buckets and pails are often signs of leaking plumbing.

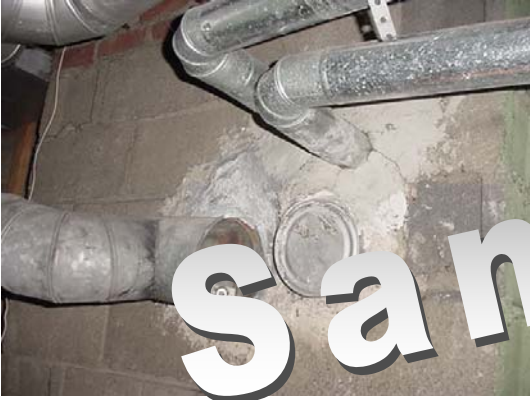
Photo 12 – Loose exhaust stacks are a carbon monoxide risk. Multiple stacks in this arrangement are out of code compliance.

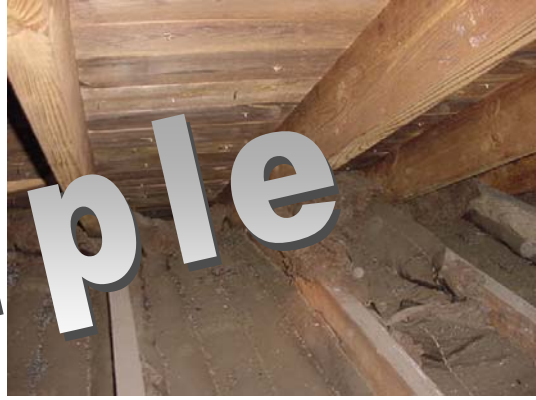
Photo 14 – Cellulose insulation is minimal and chocks off ventilation where adequate. Recommend adding R-19 fiberglass batts with rafter vents to assure proper ventilation through soffit.

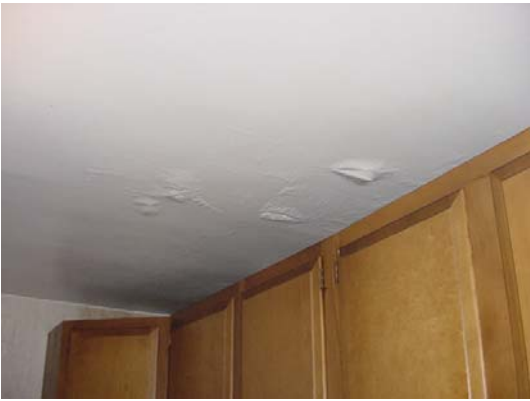
Photo 13 – Peeling paint indicates possible leaks.
